INSPECTION CONDITIONS

INSPECTION LOCATION: 123 Your Street.

CITY/STATE/ZIP: Your Town, Georgia 30001.

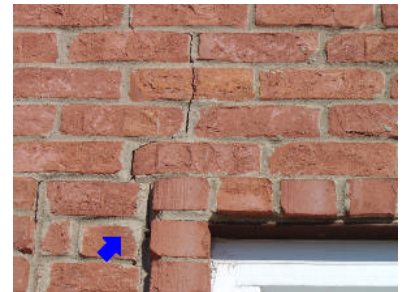
CONDITION: There is a crack in the brick venner above and between the garage doors. Monitoring of this crack for additional movement is recommended.

There is some swelling of the bottom edge of the composition siding. The siding is beginning to delaminate on the bottom of the wall on the right side of the house. Two pieces of siding have been replaced. To preserve the siding for as long as possible it is recommended that the siding be carefully caulked and painted by a qualified painting contractor. Siding on the upper walls and the chimney chase has been installed closer than 2 inches to roofing.

There is a crack in the brick veneer above and between the garage doors. Monitoring of this crack for additional movement is recommended.

There is some swelling of the bottom edge of the composition siding. The siding is beginning to delaminate on the bottom of the wall on the right side of the house. Two pieces of siding have been replaced. To preserve the siding for as long as possible it is recommended that the siding be carefully caulked and painted by a qualified painting contractor.

Siding on the upper walls and the chimney chase has been installed closer than 2 inches to roofing.

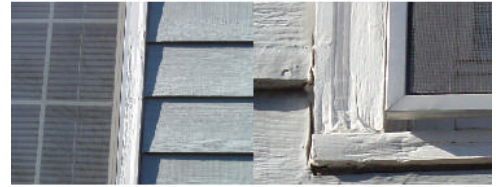
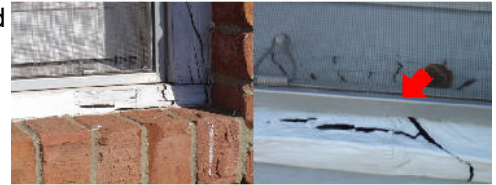
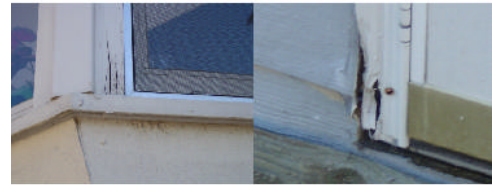
Decayed wood trim was noted in the following locations: The window sill and the left jamb of the left front bedroom window, the trim on all of the right side windows except the new basement window, the trim and sill on the rear family room windows, the sill of the front window on the front left side bay, the master bathroom window sill, the bottom of the trim on the door to the deck, and the bottom of the trim on the front of the rear left side bay. All damaged or decayed trim should be repaired/replaced as necessary by a qualified general contractor. A piece of trim has been removed from the bottom of the rear left side bay window. This has left exposed, unpainted wood in this location.

Decayed wood trim was noted in the following locations: The window sill and the left jamb of the left front bedroom window, the trim on all of the right side windows except the new basement window, the trim and sill on the rear family room windows, the sill of the front window on the front left side bay, the master

bathroom window sill, the bottom of the trim on the door to the deck, and the bottom of the trim on the front of the rear left side bay. All damaged or decayed trim should be repaired/replaced as necessary by a qualified general contractor.

A piece of trim has been removed from the bottom of the rear left side bay window. This has left exposed, unpainted wood in this location.

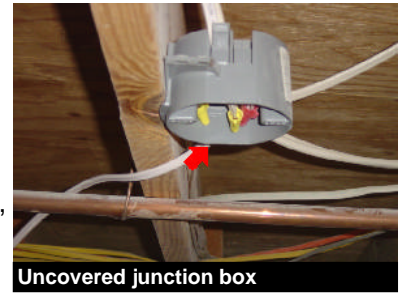
Uncovered junction boxes were observed above the basement suspended ceiling in the basement master bedroom, the basement hall between the dining and living areas, and in the hallway at the at the bottom of the stairs. Further evaluation and correction of all electrical problems as necessary by a qualified, licensed electrician is recommended.

Uncovered junction boxes were observed above the basement suspended ceiling in the basement master bedroom, the basement hall between the dining and living areas, and in the hallway at the bottom of the stairs. Further evaluation and correction of all electrical problems as necessary by a qualified, licensed electrician is recommended.

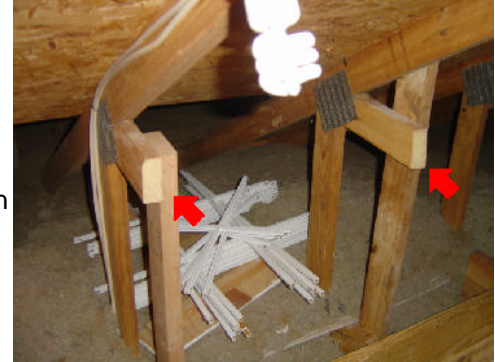
CONDITION: Trusses have been cut for installation of the attic pull down stairway. All members of a truss are structural and cannot be altered. Repair for this condition should be designed by a qualified, registered engineer. No plywood clips have been installed in the roof sheathing.

Trusses have been cut for installation of the attic pull down stairway. All members of a truss are structural and cannot be altered. Repair for this condition should be designed by a qualified, registered engineer.

No plywood clips have been installed in the roof sheathing.
